Structural Tests of Mechanical Connections For Concrete Panels

L. E. Cattaneo and F. Y. Yokel

Final Report

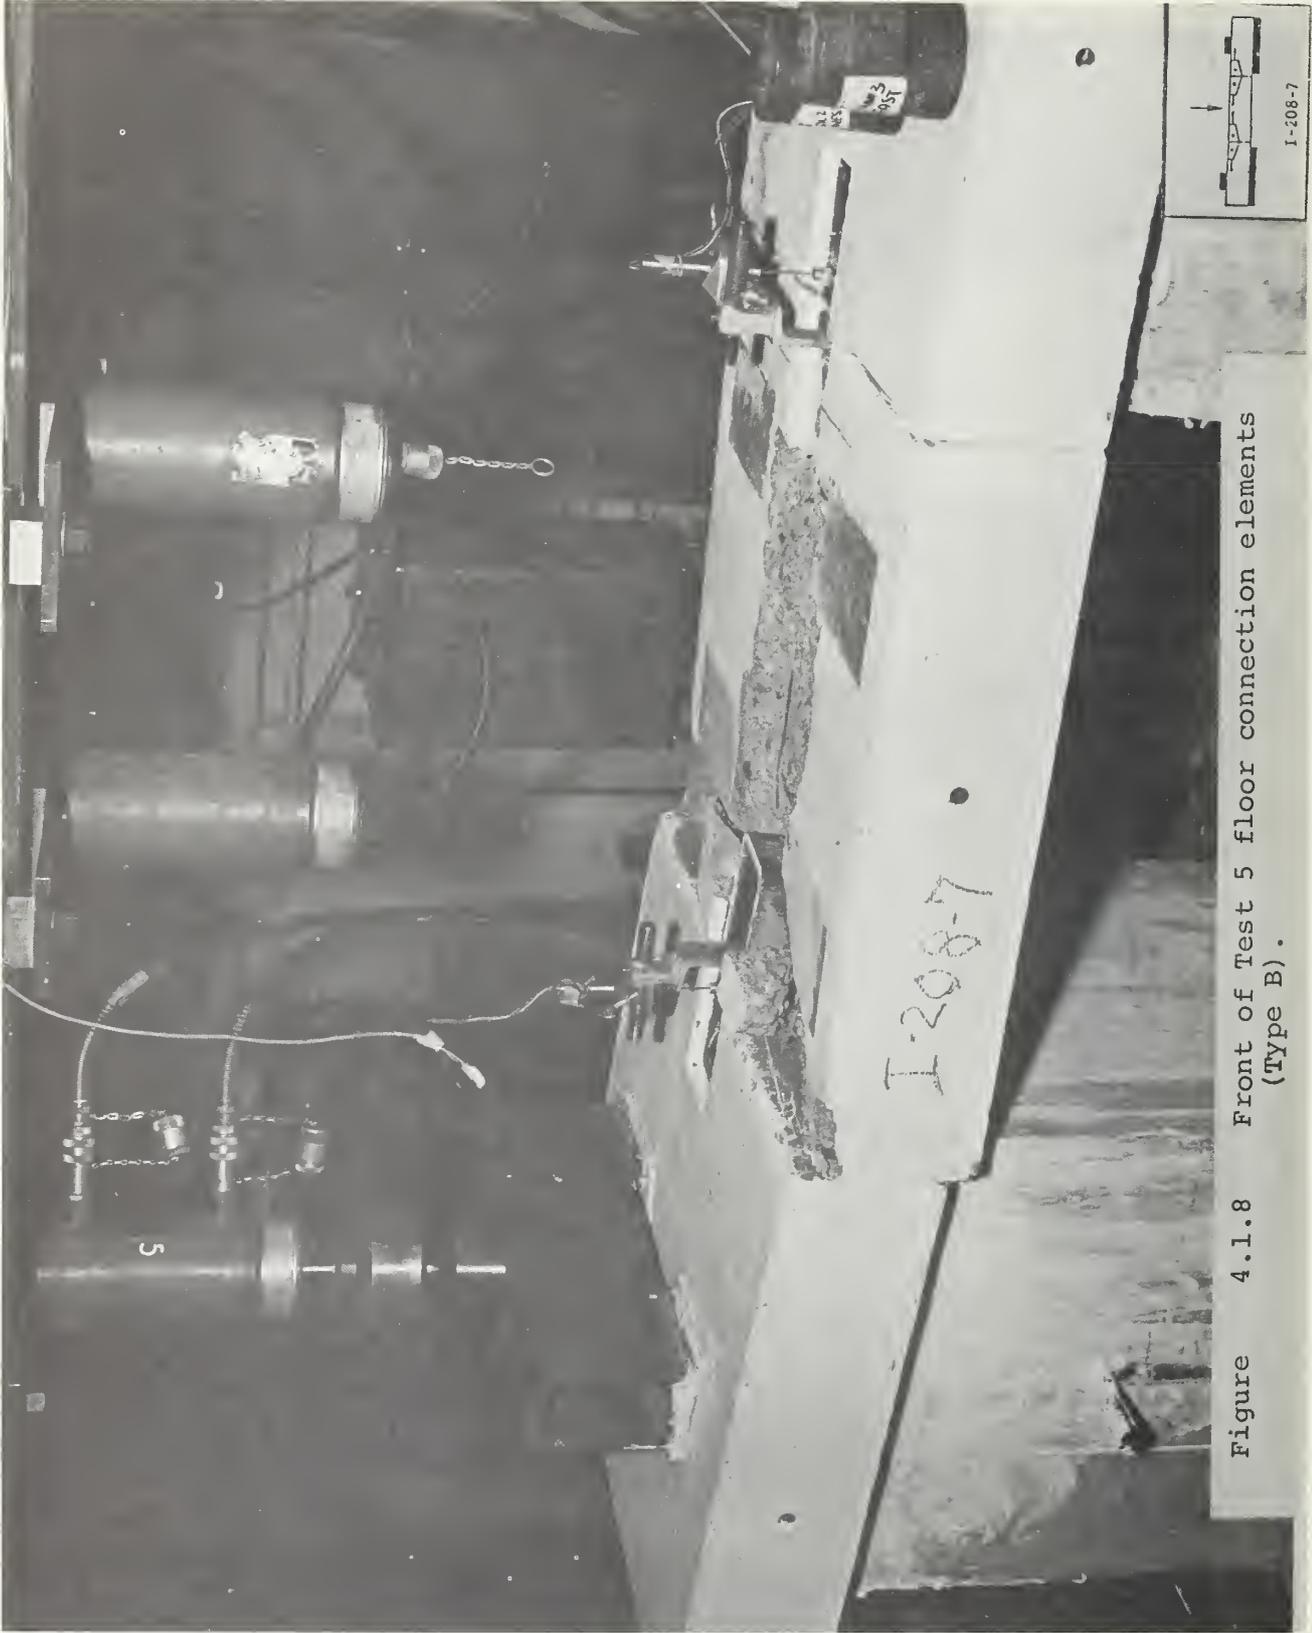
Two specimens were tested (Tests 5 and 6). The Test 5 specimen (fig. 4.1.8) used the revised reinforcement detail (figure 2.2.5) and in the Test 6 specimen the original design (fig. 2.2.1) was used. While the Test 5 specimen was ungrouted, grout was used in the tubes and the joints of the Test 6 specimen. Another difference was in the test set-up. Test 5 used restrained support conditions, (fig. 4.1.8). In Test 6 the outer slabs were unrestrained (as shown in fig. 4.1.10) and could rotate. In the actual structures, individual floor slabs are only partially restrained from rotation and grouting of the joint might not be used. Test 5 is considered the simulation which provides an indication of the connection element strength with less risk.

men resisted an ultimate load of 24 kip. Extended failure damage, as illustrated in figures 4.1.8 and 4.1.10, occurred by spalling of the concrete covering the connectors. This mode of failure was resisted by the welded wire fabric covering the connector.

Figure 4.1.8 Front of Test 5 floor connection elements (Type B).

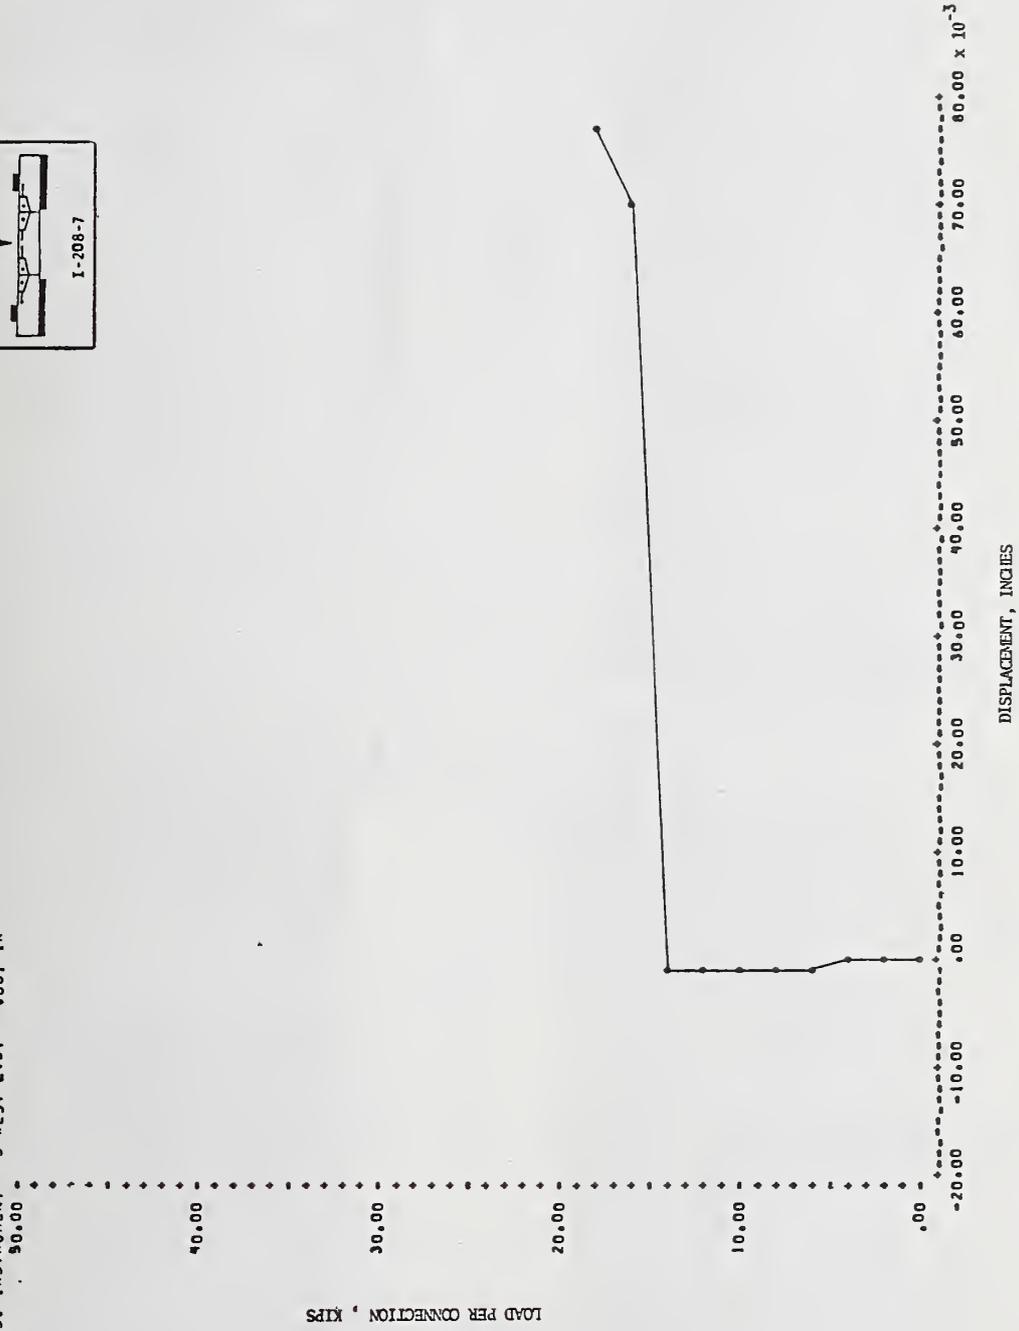
Figure 4.1.9 shows the plot of slip versus load for Test 5 which is also similar to the response observed in Test 6. It can be seen that a large displacement occurred after initial slip. This apparent yield is attributable to slipping of the connection elements. The subsequent load increase occurred when the bolt resisted additional slipping in shear. The plot does not show the entire range of the test in which the speci-

Figure 4.1.9 Load-displacement graph for left connection of Test 5.

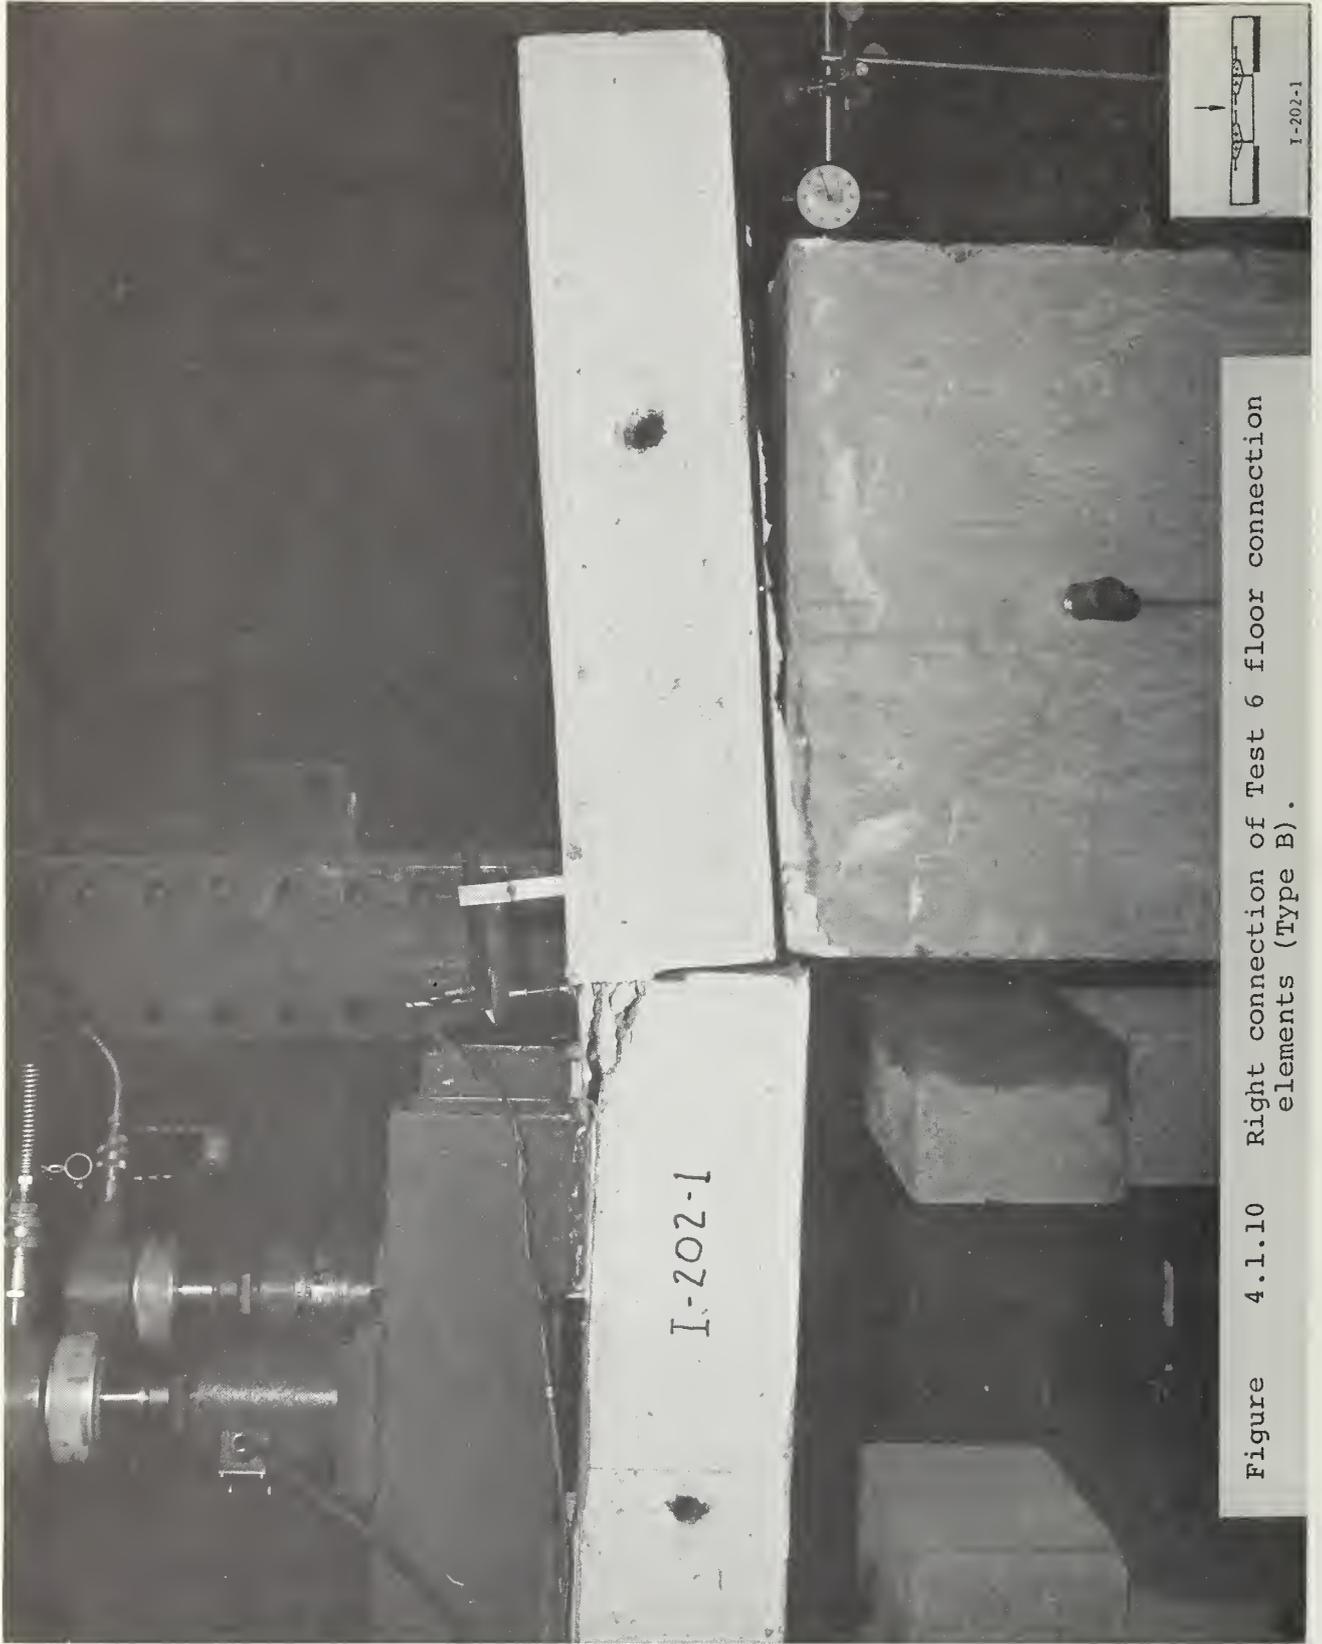
Figure 4.1.10 Right connection of Test 6 floor connection elements (Type B).

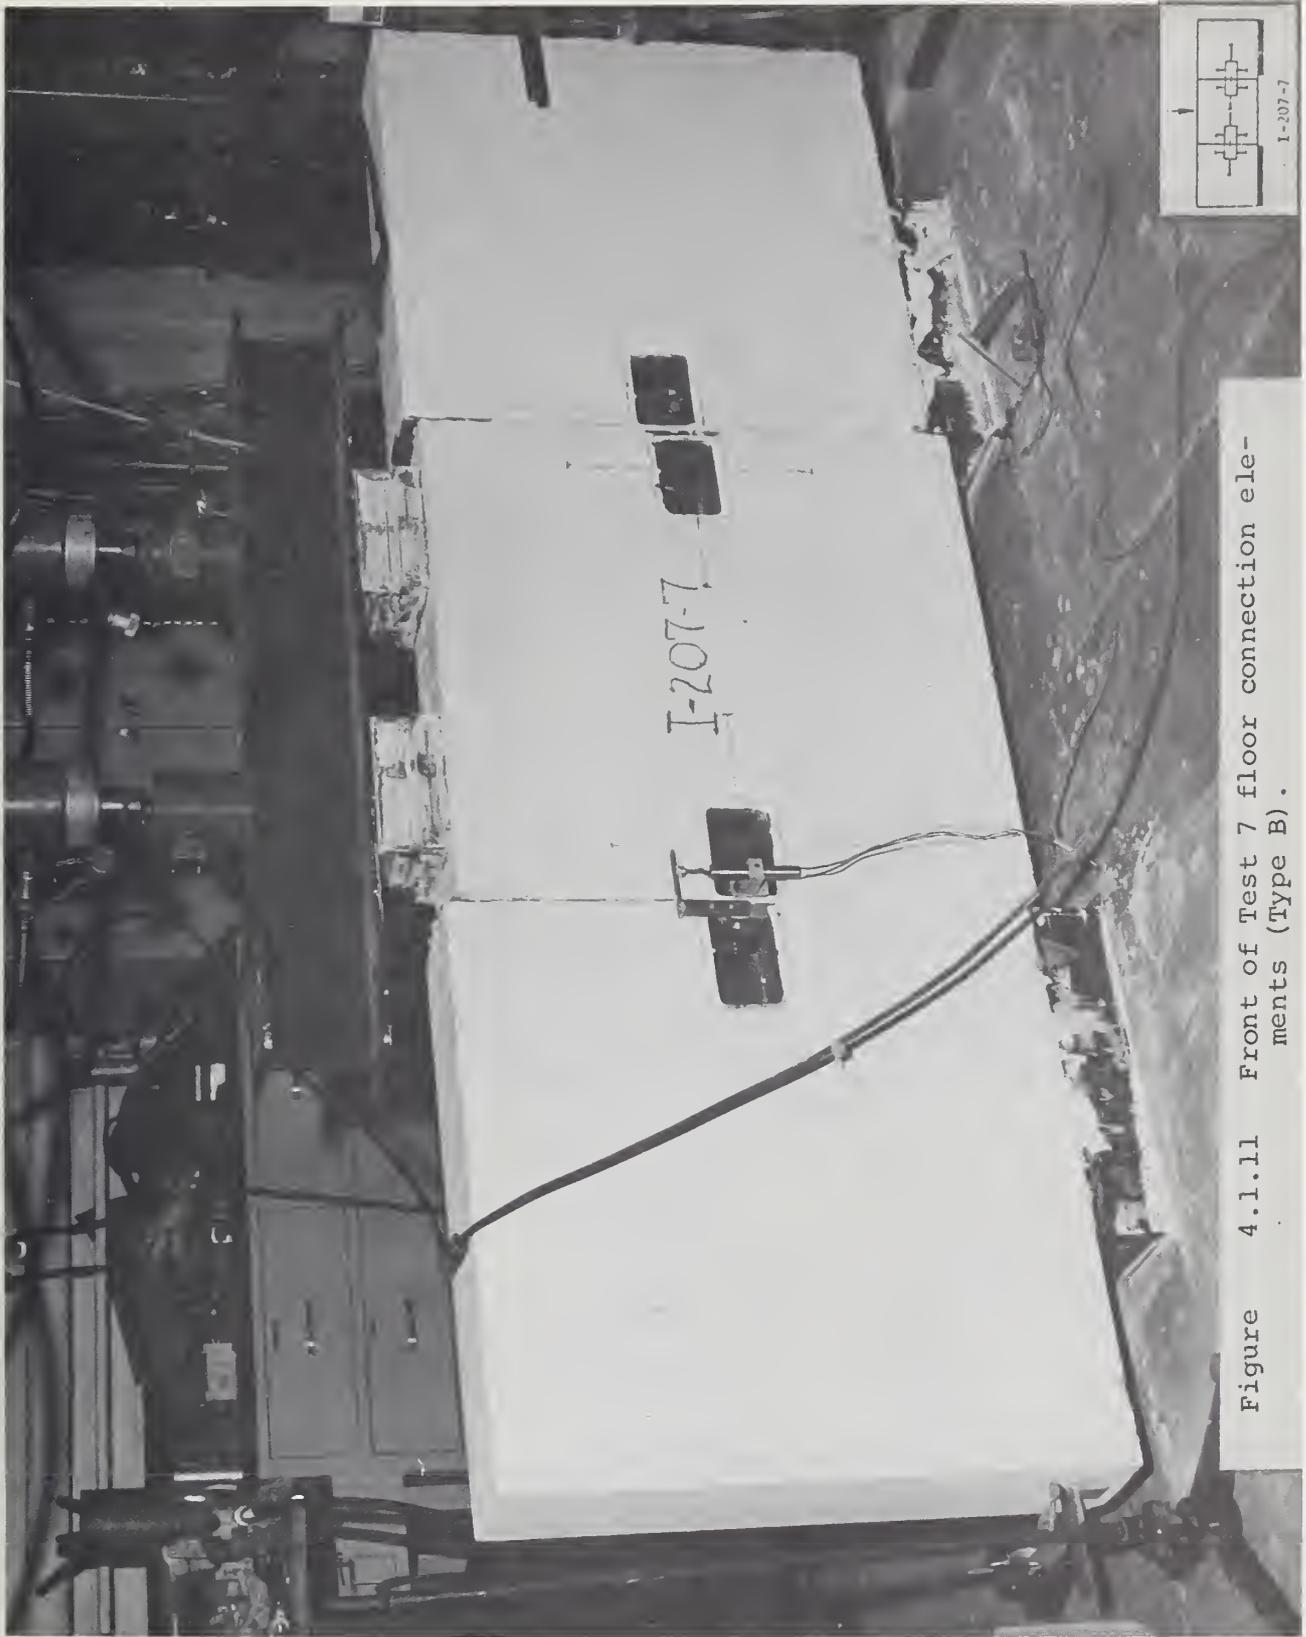
The Test 7 specimen (fig. 4.1.11) contained the revised reinforcement design (fig. 2.2.5) and no grout. The Test 9 specimen contained the revised reinforcement design and grout in the connector tubes but not in the joints. Tests 10 and 11 used specimens similar to those in Tests 7 and 9, respectively, except that the connector was located close to the corner of the slab simulating a critical design condition. Test 8 used the original design (fig. 2.2.1) and grouting of the tubes as well as the joints. Test 10 is considered the simulation which would be expected to provide the least strength. However, the variables in Tests 7, 9, 10 and 11 apparently did not affect load resistance.

Figure 4.1.11 Front of Test 7 floor connection elements (Type B).

I-207-7	Floor to Floor	4.1.11 4.1.12 ^g	(Revis.) 2.2.5	6540	w/o	B	3/4	28400	Horiz. (In-plane) Shear	10.0*	Initial slip	Loaded to 34.5kip/conn. max. at 30.45 in total deformation; shear failure of bolt.

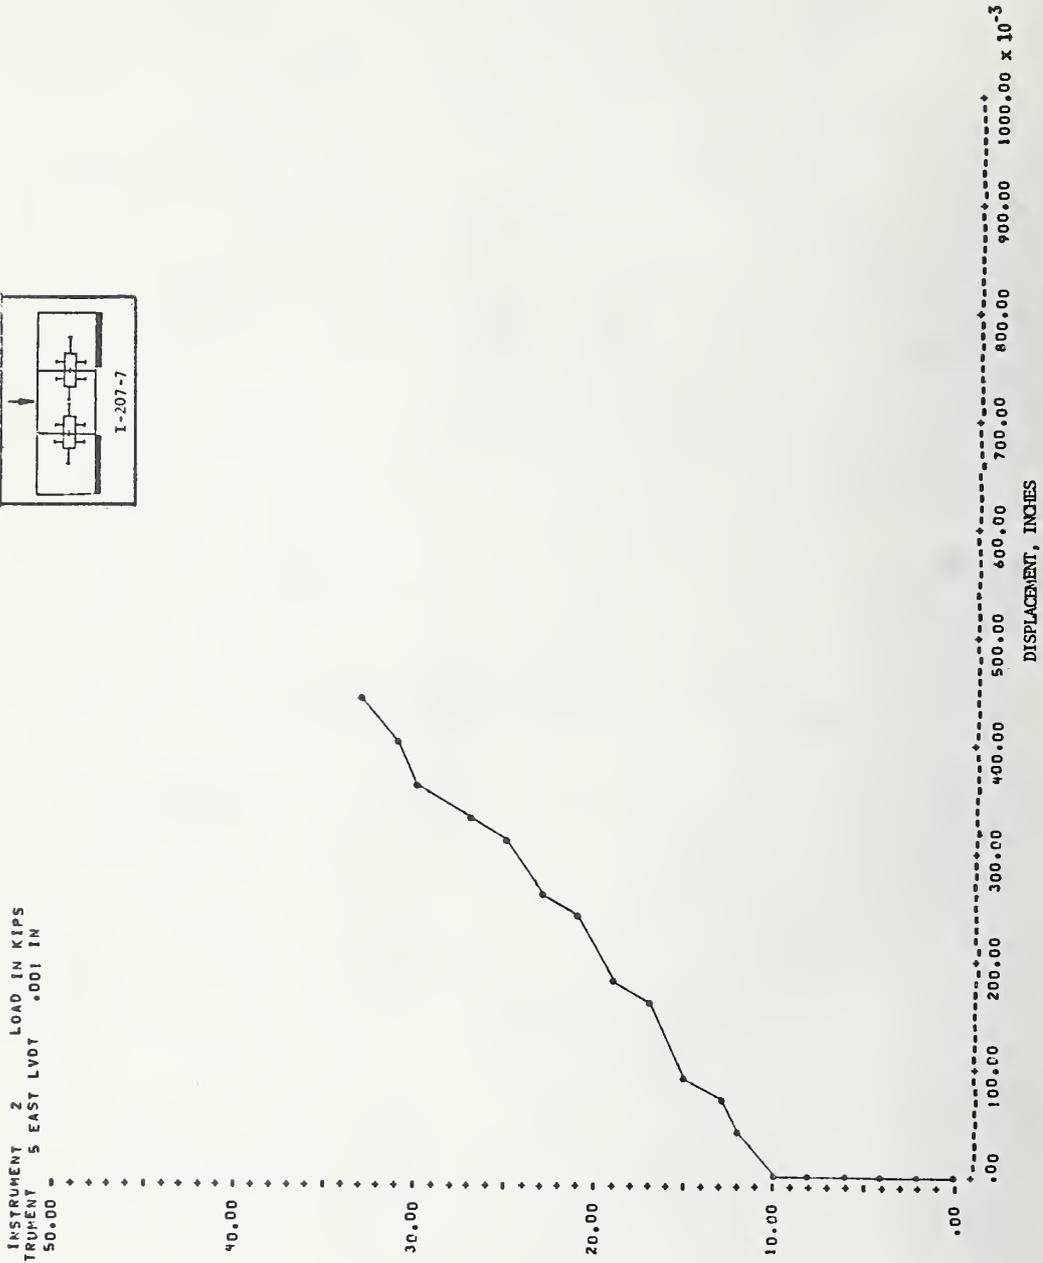
A typical resistance curve is shown in figure 4.1.12 which illustrates the load-displacement relationship for Test 7. Up to 10.0 kip the load was resisted by the friction force. Subsequently, large deformations were associated with additional loading. The 10-kip load is identified as the failure load. The ultimate load is 34.5 kip. Collapse occurred by shearing of the high-strength bolt, (see figures 4.1.11 and 4.1.13). No concrete failure was observed in Tests 7 through 9. In Tests 10 and 11, where the connector is located close to a corner, the concrete was sheared in addition to the connections failing by slip as shown in figures 4.1.14, 4.1.15, 4.1.16 and 4.1.17. In Test 11 the bolt was sheared in addition to the concrete failure, while the Test 10 specimen reached ultimate load by shearing of the concrete without fracture of the bolt. In spite of the differences in their failure modes the resistance curves, as well as the failure loads and maximum loads, are similar in Tests 7, 9, 10 and 11. Test 8, which used grout in the tubes and joints, developed a much higher frictional resistance; however, the maximum load was similar to that of the other test specimens. Since the integrity of grout in joints like those in Test 8 can not be assured because of their small widths, and since grouting might not be used in all cases, it is concluded that the results of Tests 7, 9, 10 and 11 give an indication of the load capacity of the connection element.

Figure 4.1.12 Load-displacement graph for right connection of Test 7.

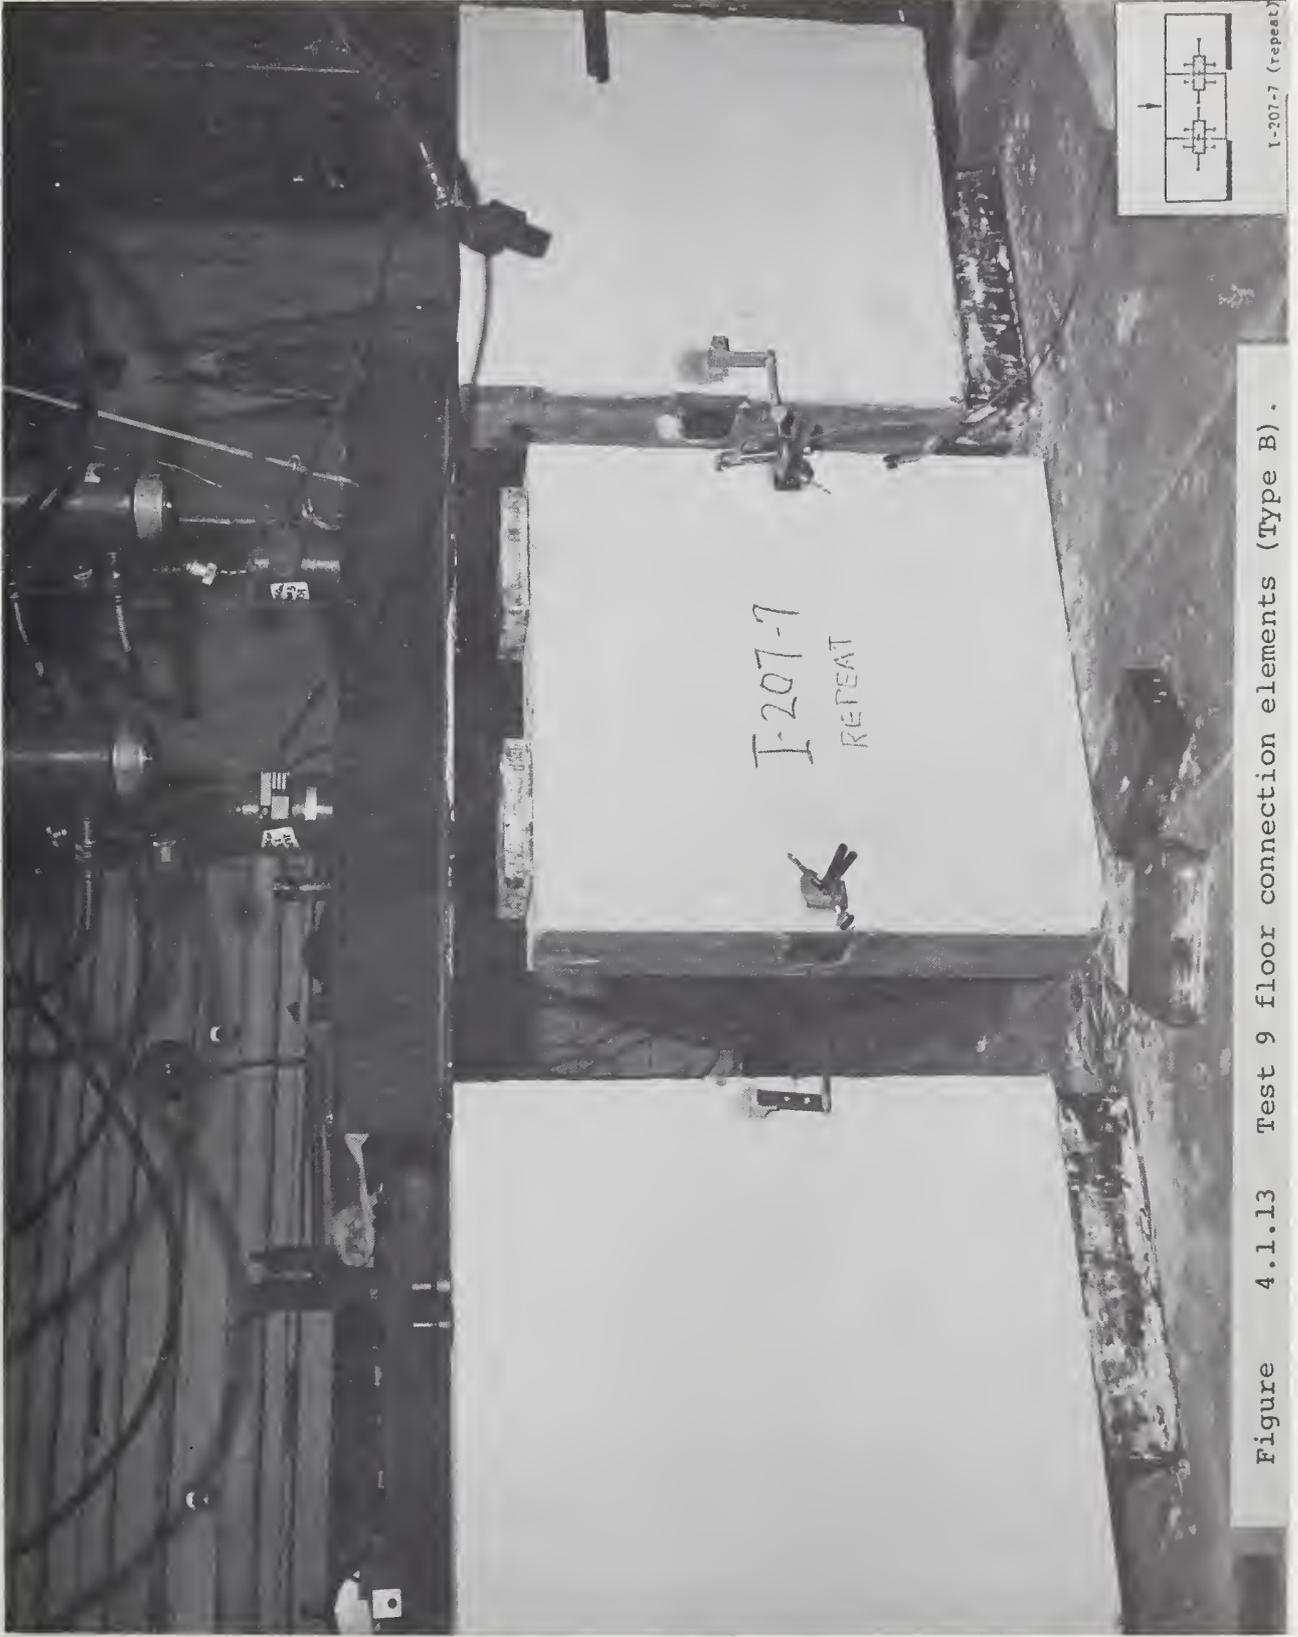
Figure 4.1.13 Test 9 floor connection elements (Type B).

I-207-7 (repeat)	Floor to Floor	4.1.13	(Revis.) 2.2.5	6400	(In inserts only) 6950	B	3/4	28400	Horiz. (In-plane) Shear	11.7	Initial slip	Loaded to 35.5 kip/conn. max. at >0.95 in total deformation; shear failure of both bolts; LVDT's mounted on insert tube grout fill.
10

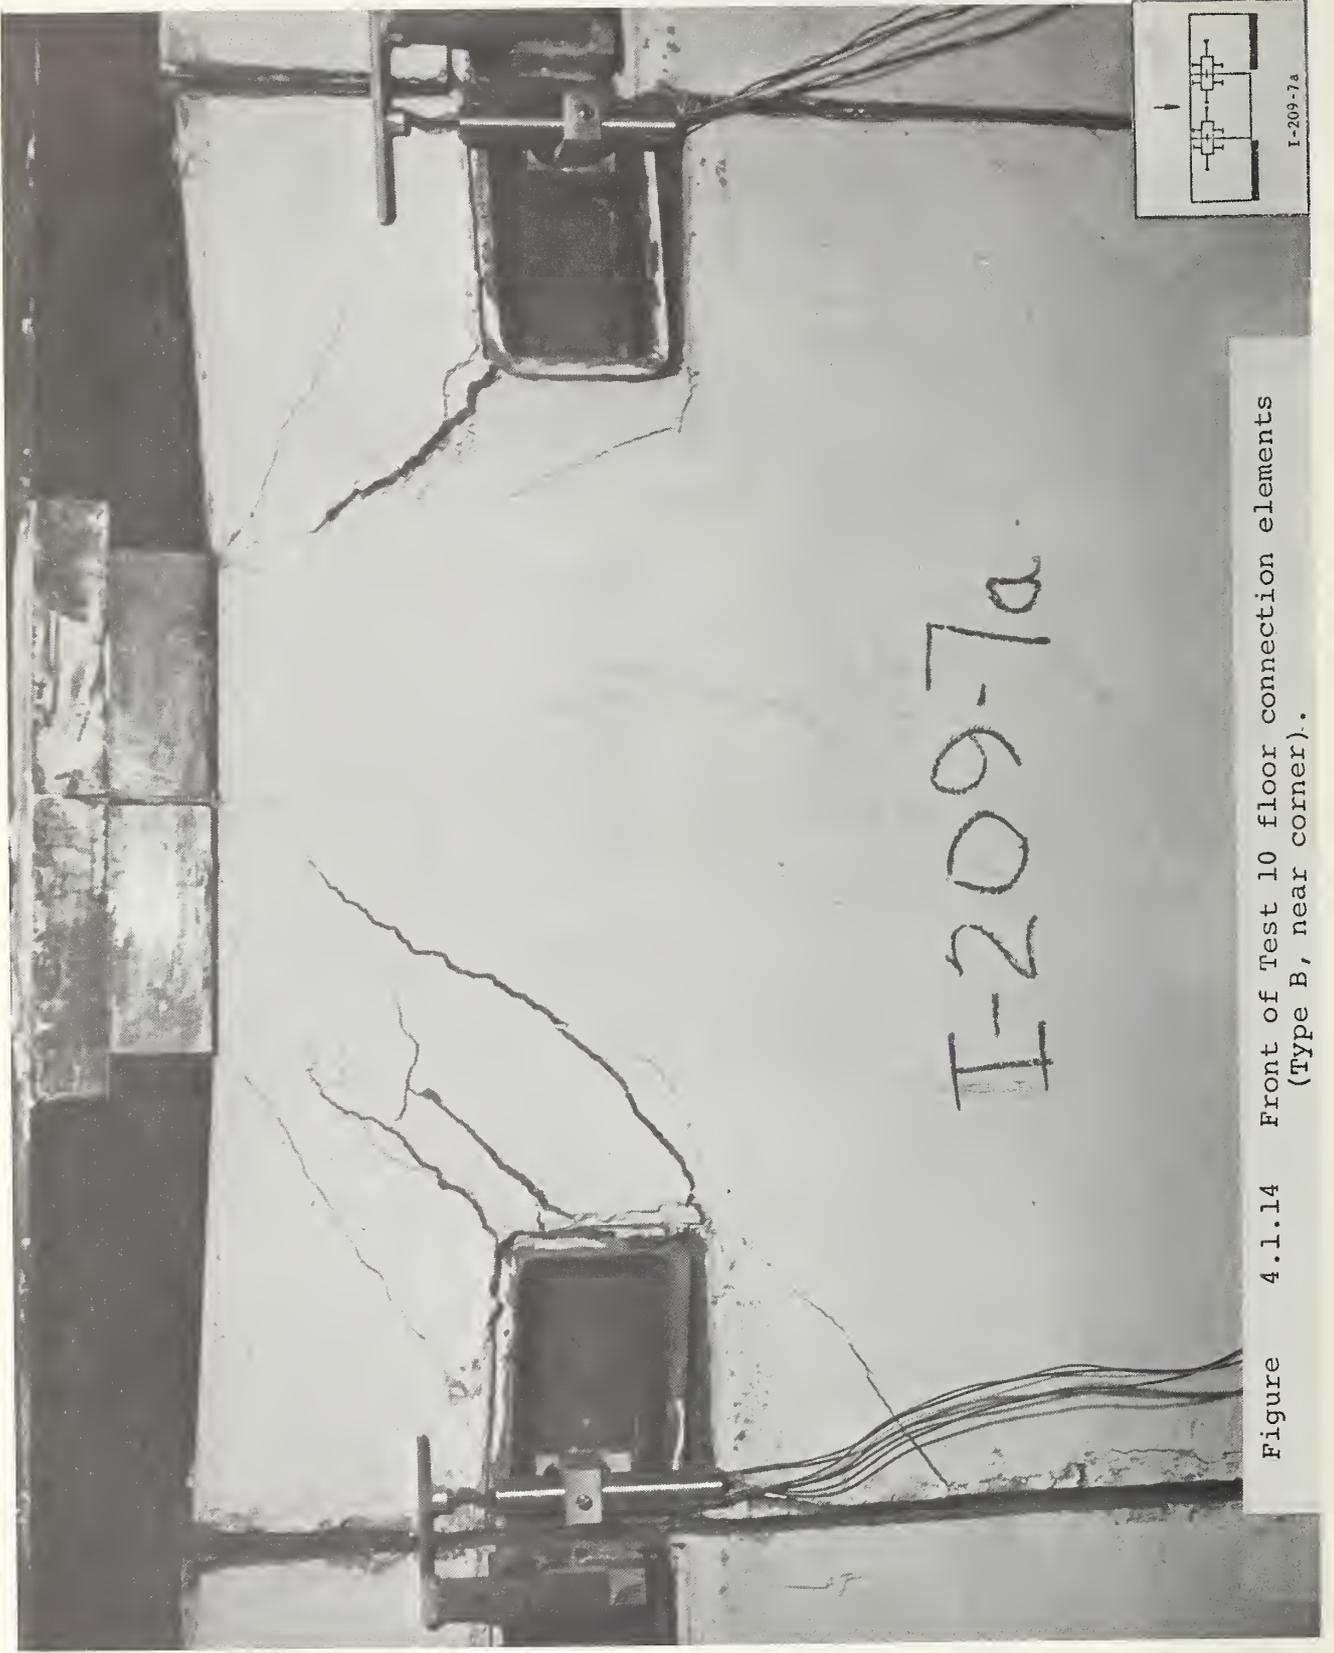
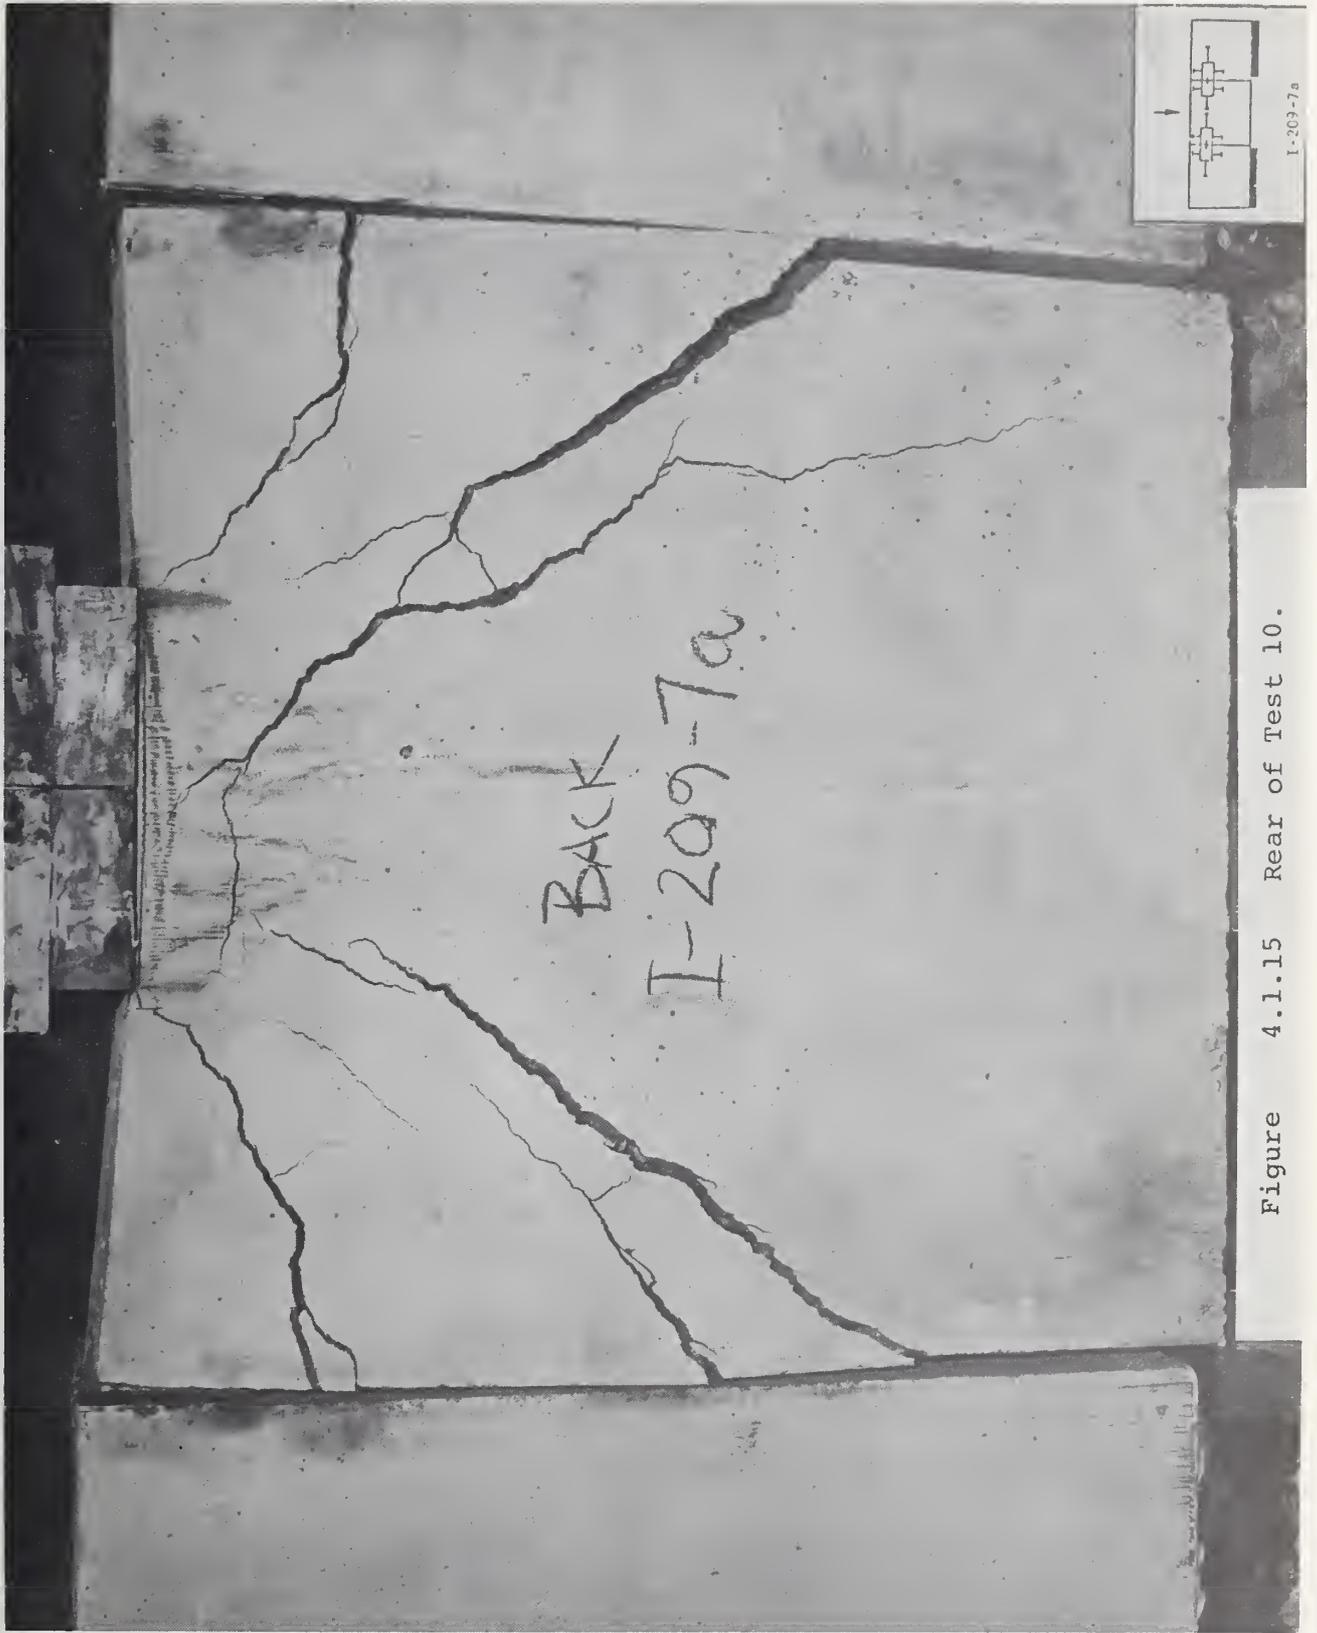
failure observed in Tests 10 and 11 (see figs. 4.1.14 through 4.1.17) by additional reinforcement designed to prevent diagonal tension cracks.

Figure 4.1.14 Front of Test 10 floor connection elements
(Type B, near corner).

Figure 4.1.15 Rear of Test 10.

For the case using Type B elements simulated in Tests 10 and 11, an improved arrangement of reinforcement in the vicinity of the connection would prevent shear failure of the concrete near the corner of the slab.

I-209-7a	Floor to Floor (near corner)	4.1.14 4.1.15	(Revis.) 2.2.6	5550	w/o	B	3/4	28400	Horiz. (In-plane) Shear	10.0*	Initial slip	Loaded to 33 kip/conn. max. at >0.5 in total deformation; multiple cracks around raked insert tubes.

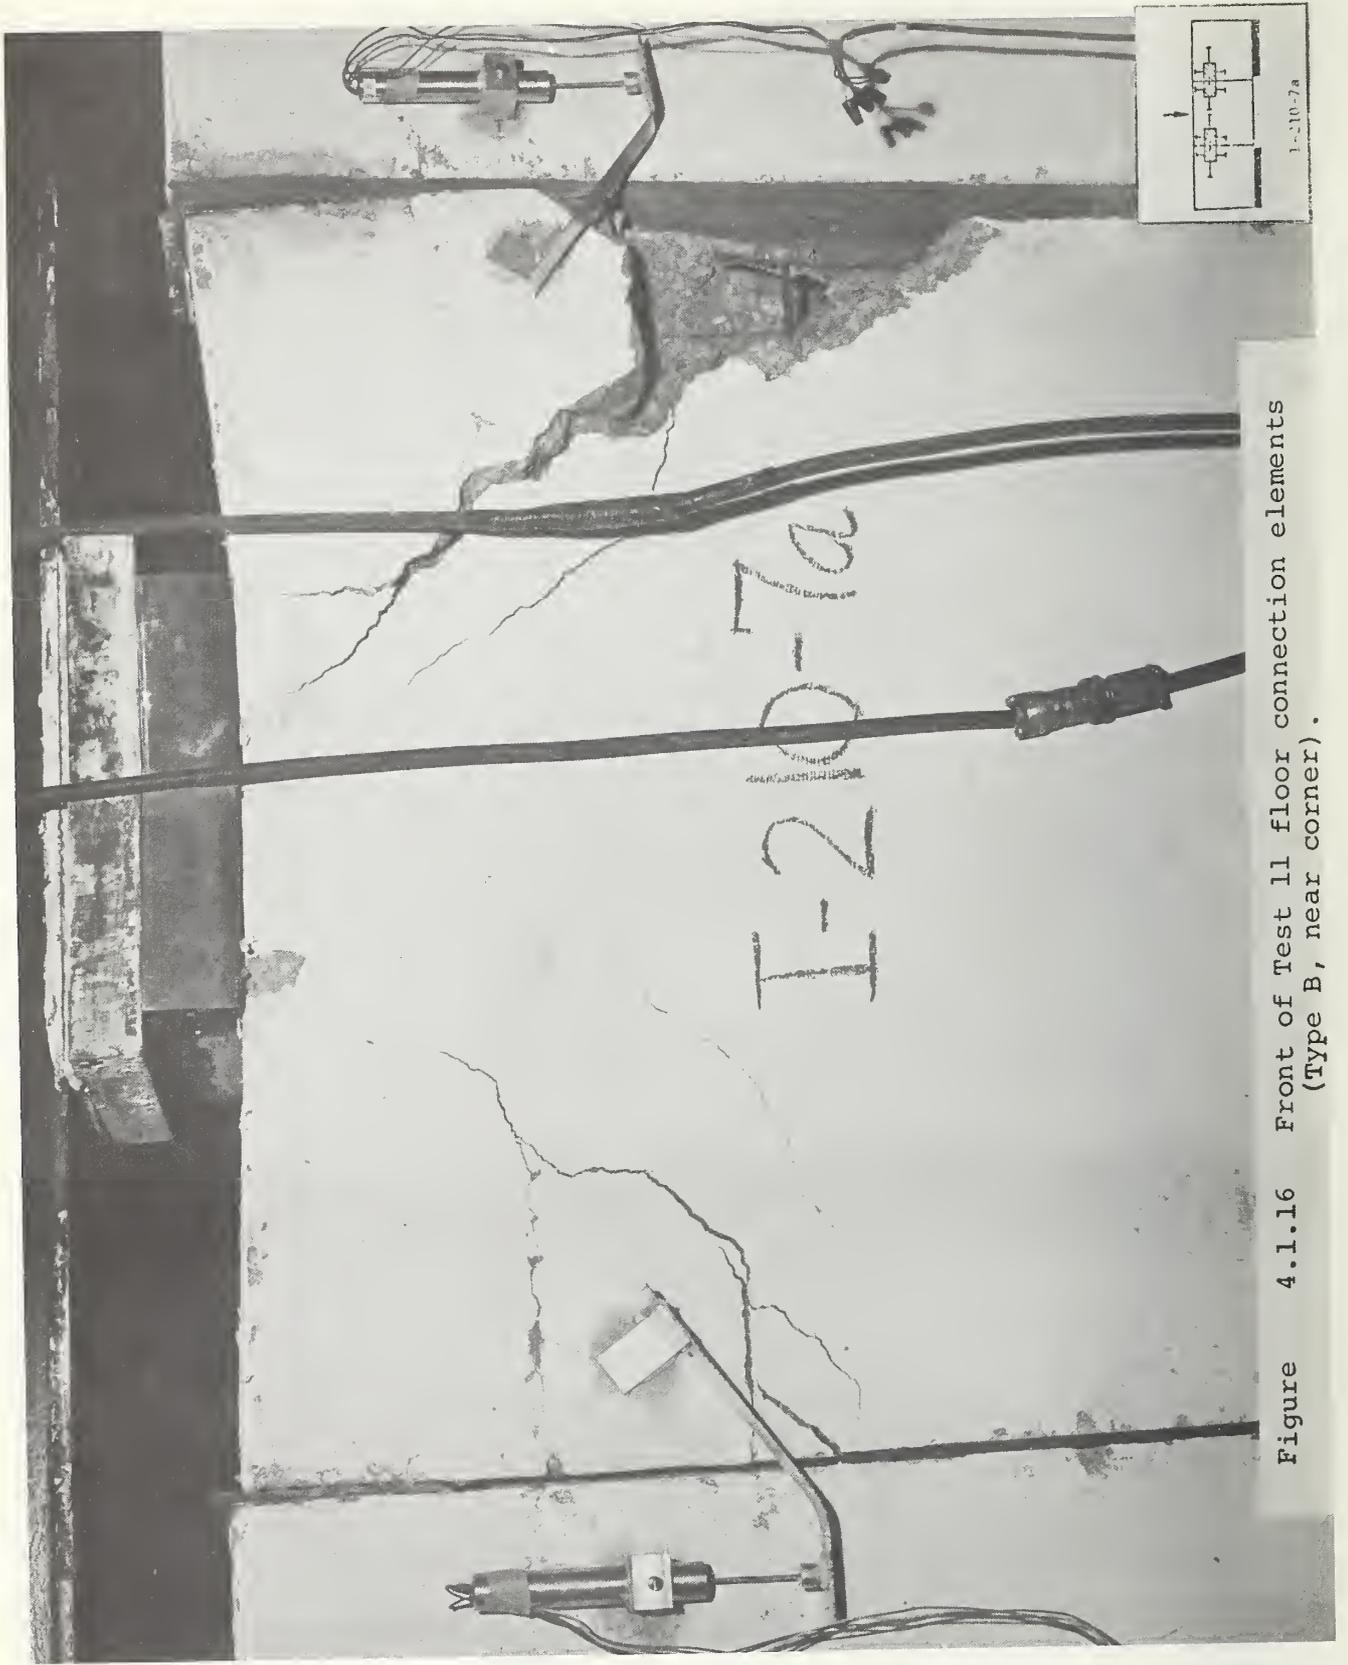
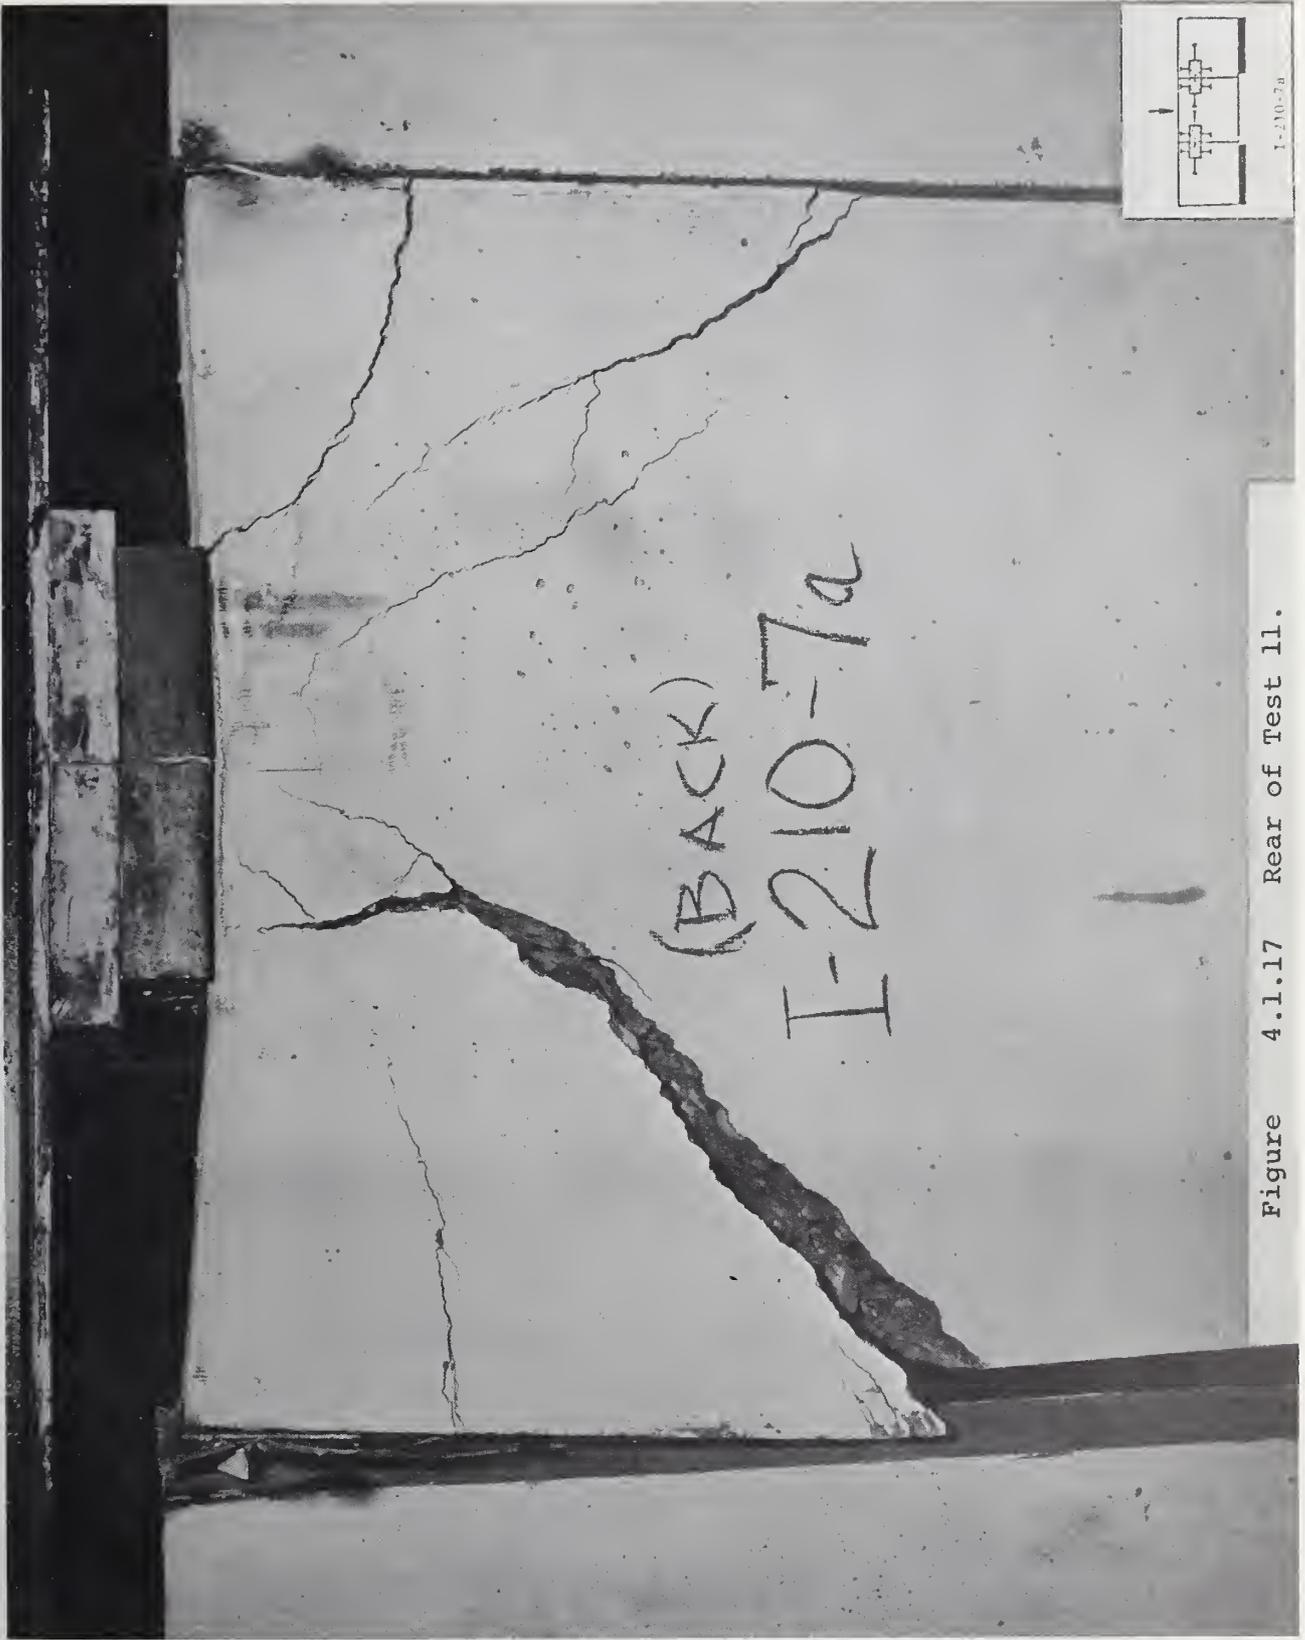
Figure 4.1.16 Front of Test 11 floor connection elements (Type B, near corner).

Figure 4.1.17 Rear of Test 11.

I-210-7a	Floor to Floor (near corner)	4.1.16 4.1.17	(Revis.) 2.2.6	5840	(In inserts only) 6050	B	3/4	28400	Horiz. (In-plane) Shear	11.0	Initial slip	Loaded to 30 kip/conn. max. at >0.2 in total deformation; LVDT's mounted on insert tube grout fill; shear failure of bolt.
12
